**The Lakeshore Guardian, 2004 October**  
**Thumb Habitats**  
**The New Galbraith Drain**  
**A Project of the Saint Clair County Drain Commissioner**  
**by Bill Collins**

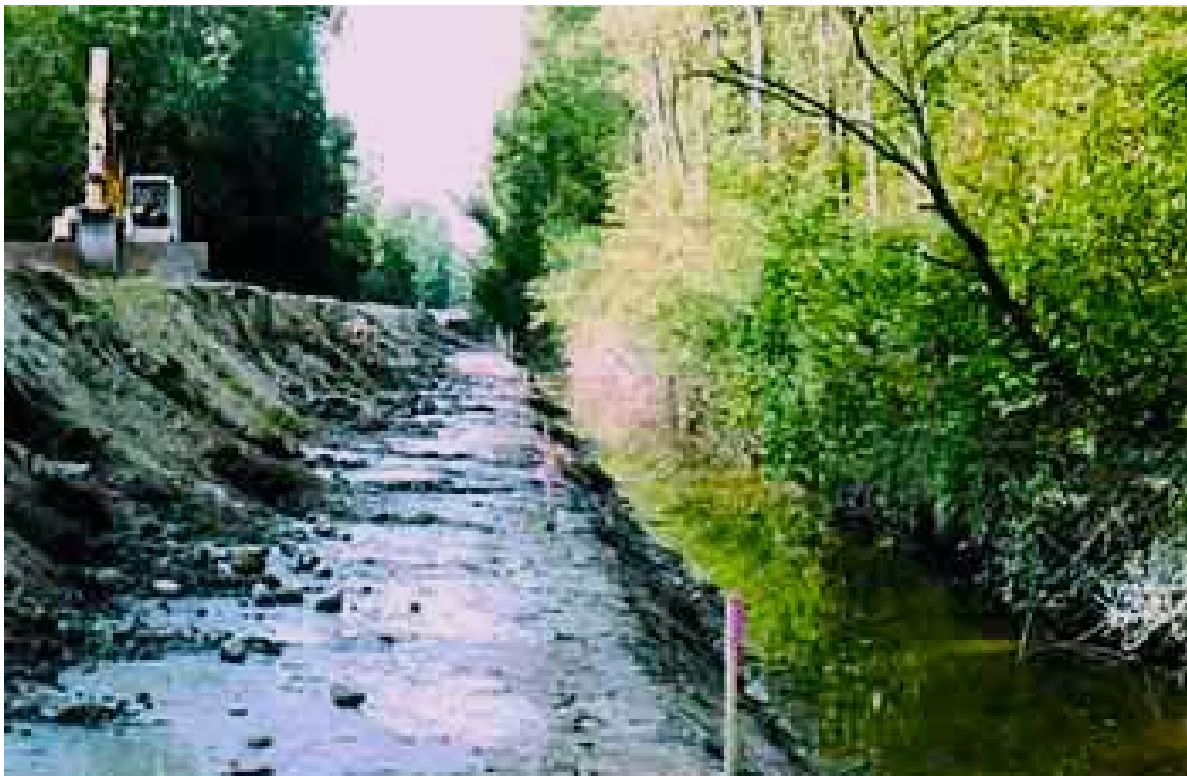
Initial excavation of floodplain shelf. Galbraith Drain at right. Original top-of-bank was about same height as excavator at upper left. Note shallow groundwater seepage from sand (left) across lakeplain clay (middle). Photograph by Bill Collins, 2004 August 24.

As shown in the photographs, basically a shelf was excavated alongside of the drain that will serve as a floodplain, a flat area that receives floodwaters from the adjoining watercourse. The photograph with the backhoe shows sand being removed down to the lakeplain clay, a layer of clay deposited thousands of years ago by Lake Huron. Notice that groundwater is seeping down through the sand to the clay, where it then flows out to the drain channel.

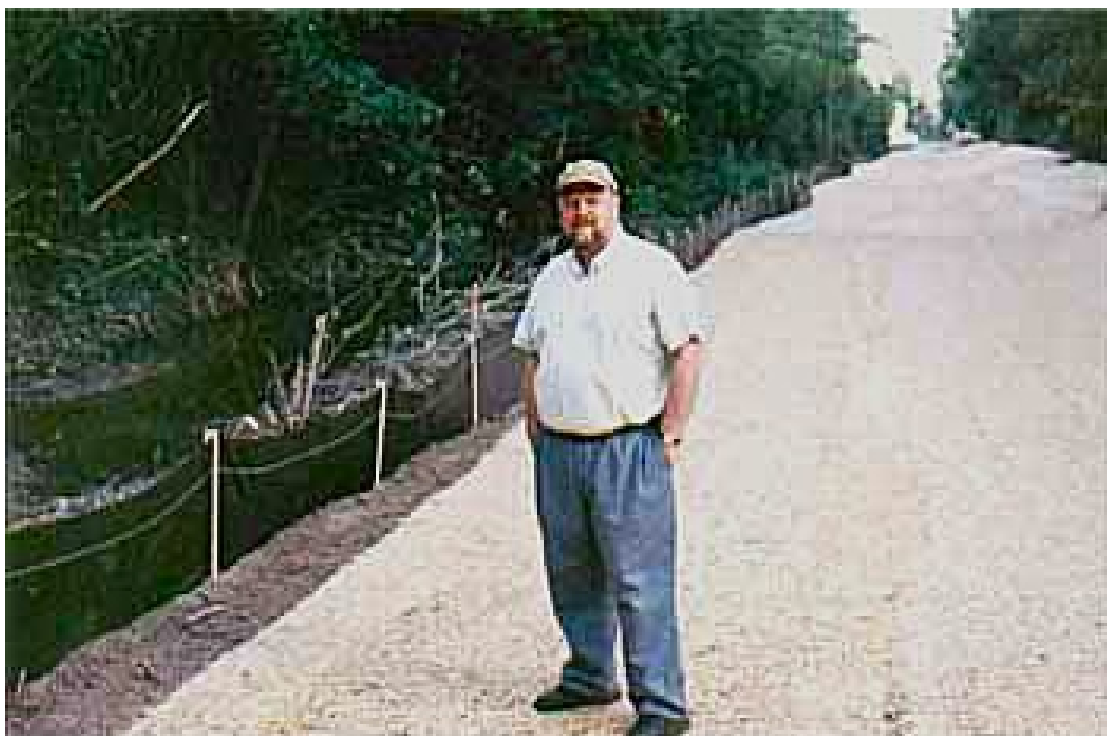
Saint Clair County Drain Commissioner, Fred Fuller, standing on erosion control matting installed on new floodplain. Galbraith Drain is left of black silt fencing.
